# **LCS-1 Freedom Reduced Manning Study Report**

Ross Davidson and Eric Wilson  
Fire Science and Technology Office  
Energetics Research Division  
Naval Air Warfare Center Weapons Division  
China Lake, CA

**AUGUST 2007**

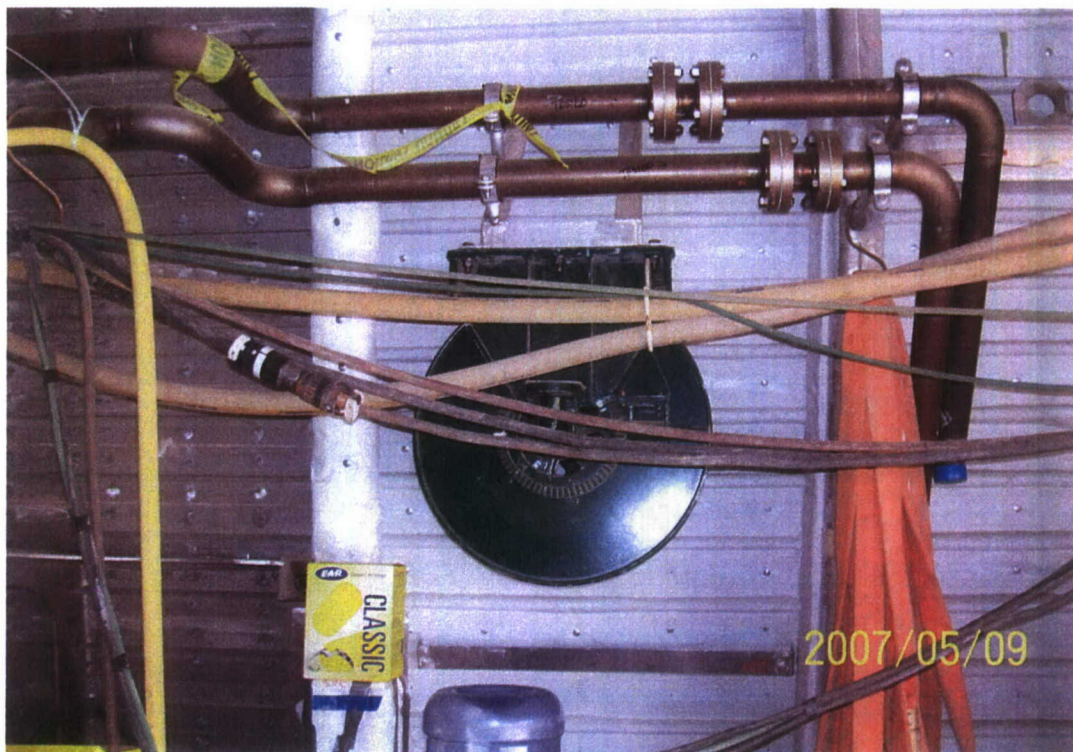
1. Starboard aft AFFF Hose Reel in Hangar: This hose reel is positioned high on the bulkhead with the Trigon control panel mounted between the hose reel and the flightdeck access door (Figures 1 and 2).

FIGURE 1. Starboard AFT AFFF Hose Reel Mounted High on Bulkhead.

The proposed correction for this situation is to install hose roller guides on the framing between the hose reel and the door. These four sided roller guide assemblies would be similar to those mounted to the hose reel shown in Figure 5.

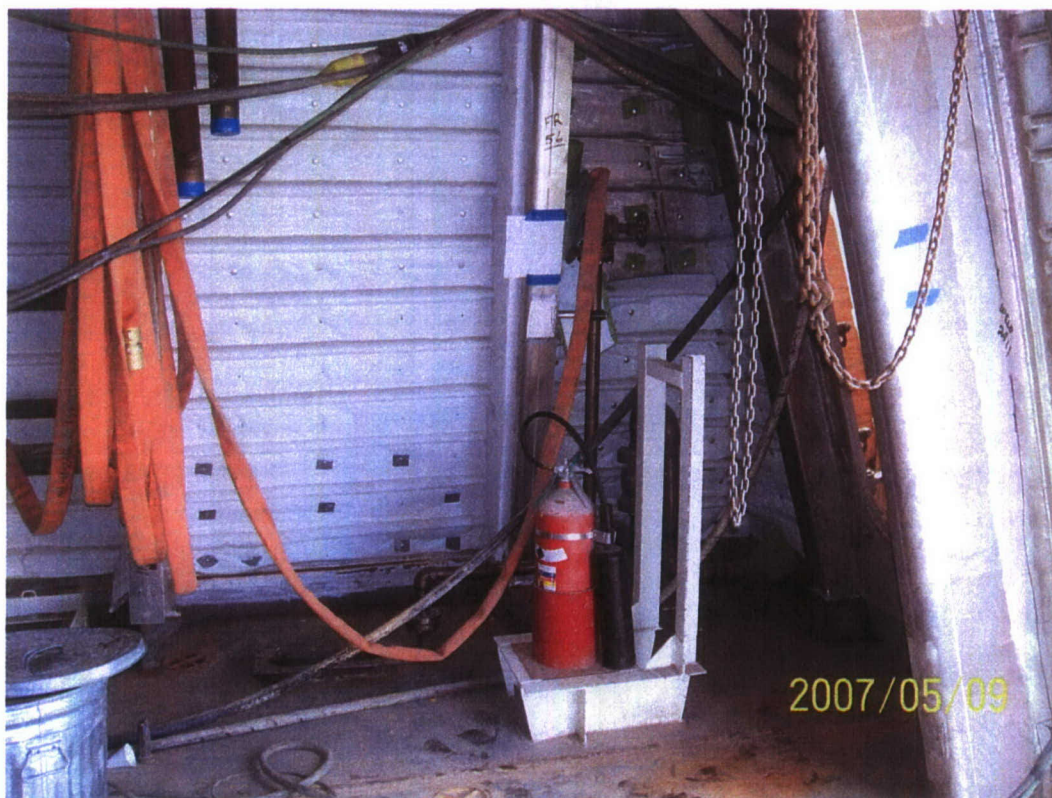
FIGURE 2. Area Between STBD AFT Reel and Flight Deck Access Door.

In this configuration it will be difficult for the hose team to pull heavy charged fire hose over the panel without hose couplings hanging up on and potentially damaging the Trigon System. There is also a three-inch diameter pipe in front of the hose reel that would impede direct feeding of hose off of the reel (Figure 3).

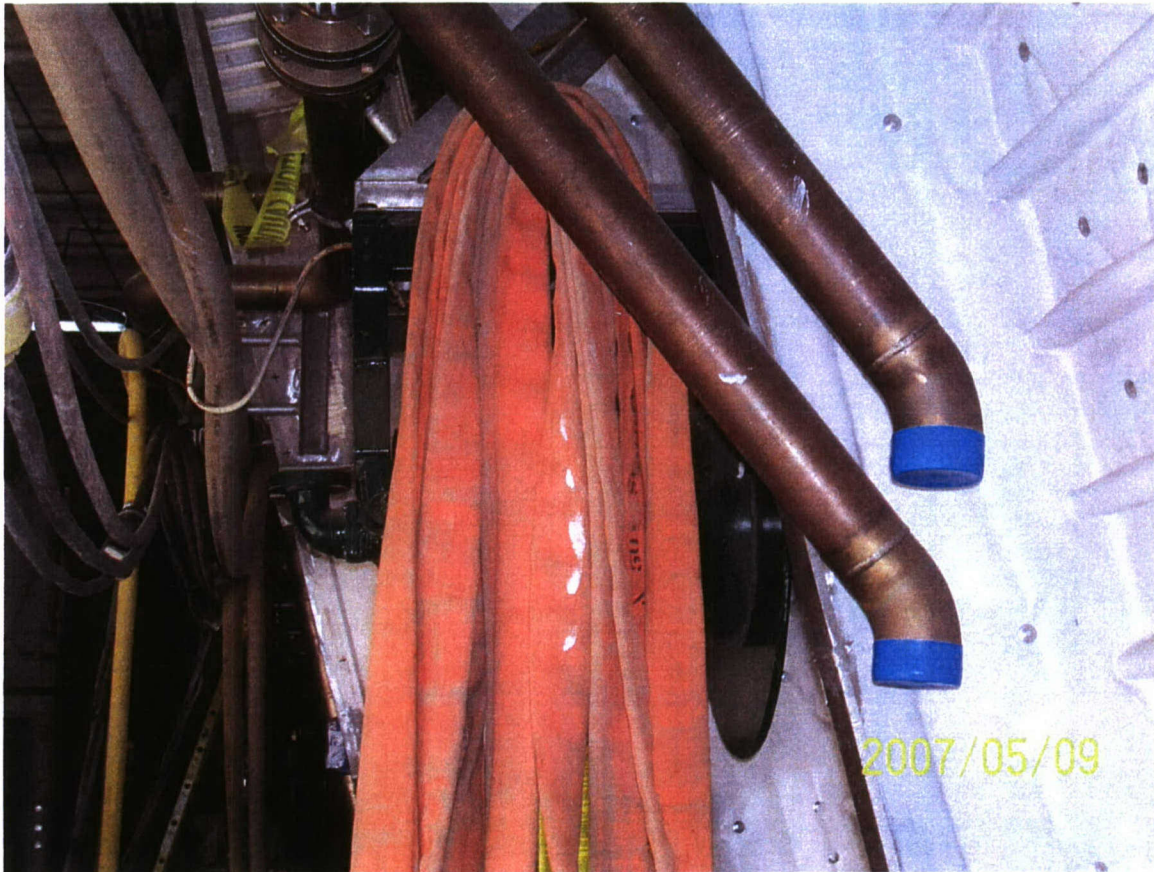
FIGURE 3. Starboard AFT AFFF Hose Reel Looking FWD. Note piping blocking hose payout.

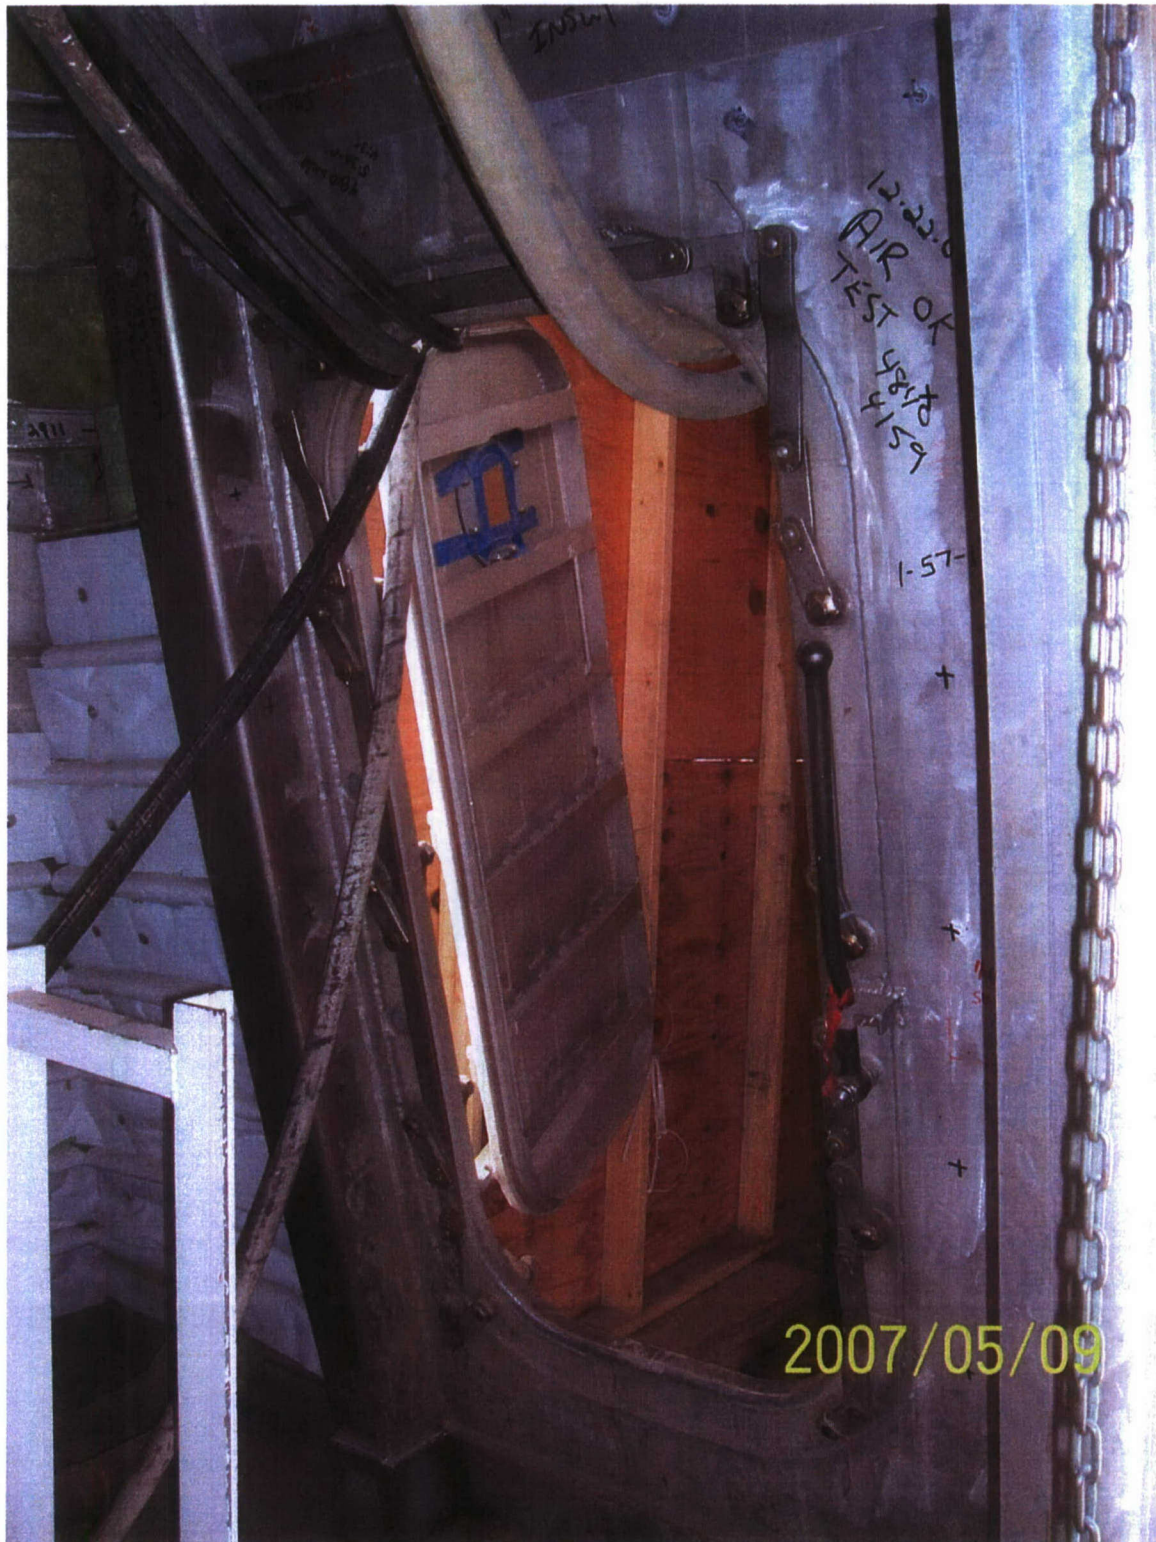
Flaking out hose on the hangar deck may help these situations, but would require hose to be played out in the primary personnel travel route from the interior of the ship to the flightdeck. The looping of the hose would also require one person to remain in the hangar as hose is being pulled to feed the hose through tight spots caused by the Trigon control panel which blocks full access through the door (Figure 4).

FIGURE 4. TRIGON Operating Console Obstructing Flight Deck Access Door.

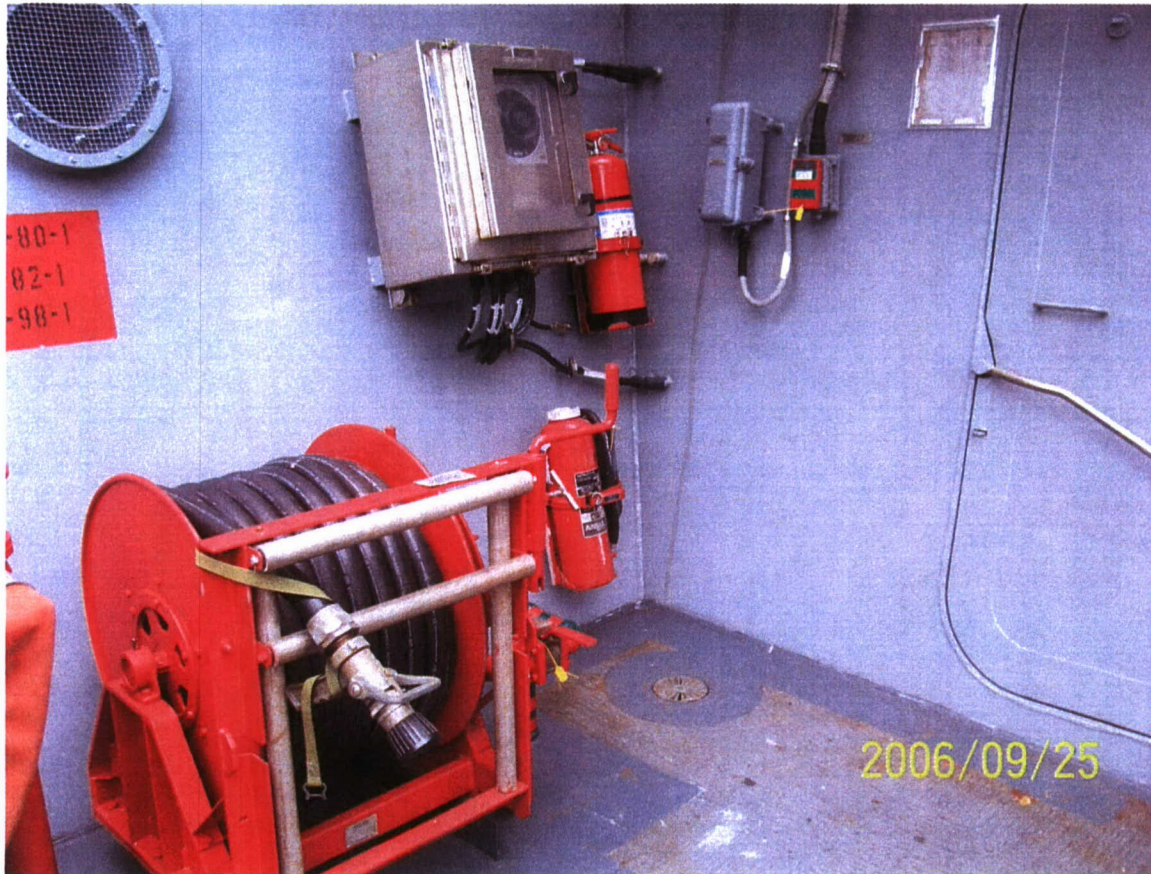
FIGURE 5. Example of Hose Roller Guide Assembly Mounted to a Reel. Suggested assemblies would mount cantilever off ship's frame to guide hose over obstructions and through door openings.

However, the proposed guide assemblies would only need to be large enough to fit a nozzle and thus could be smaller than that shown. The proposed guide assemblies would need to be designed such that they could be mounted cantilever off the frames in the subject area. This will permit the hose nozzle to be positioned at the door during flight operations. A single person will be able to immediately grab the nozzle as they exit the door and pull hose being fed off of the reel without the need to wait for a second person. Exact roller design and placement will be determined in collaboration with the LCS design team.

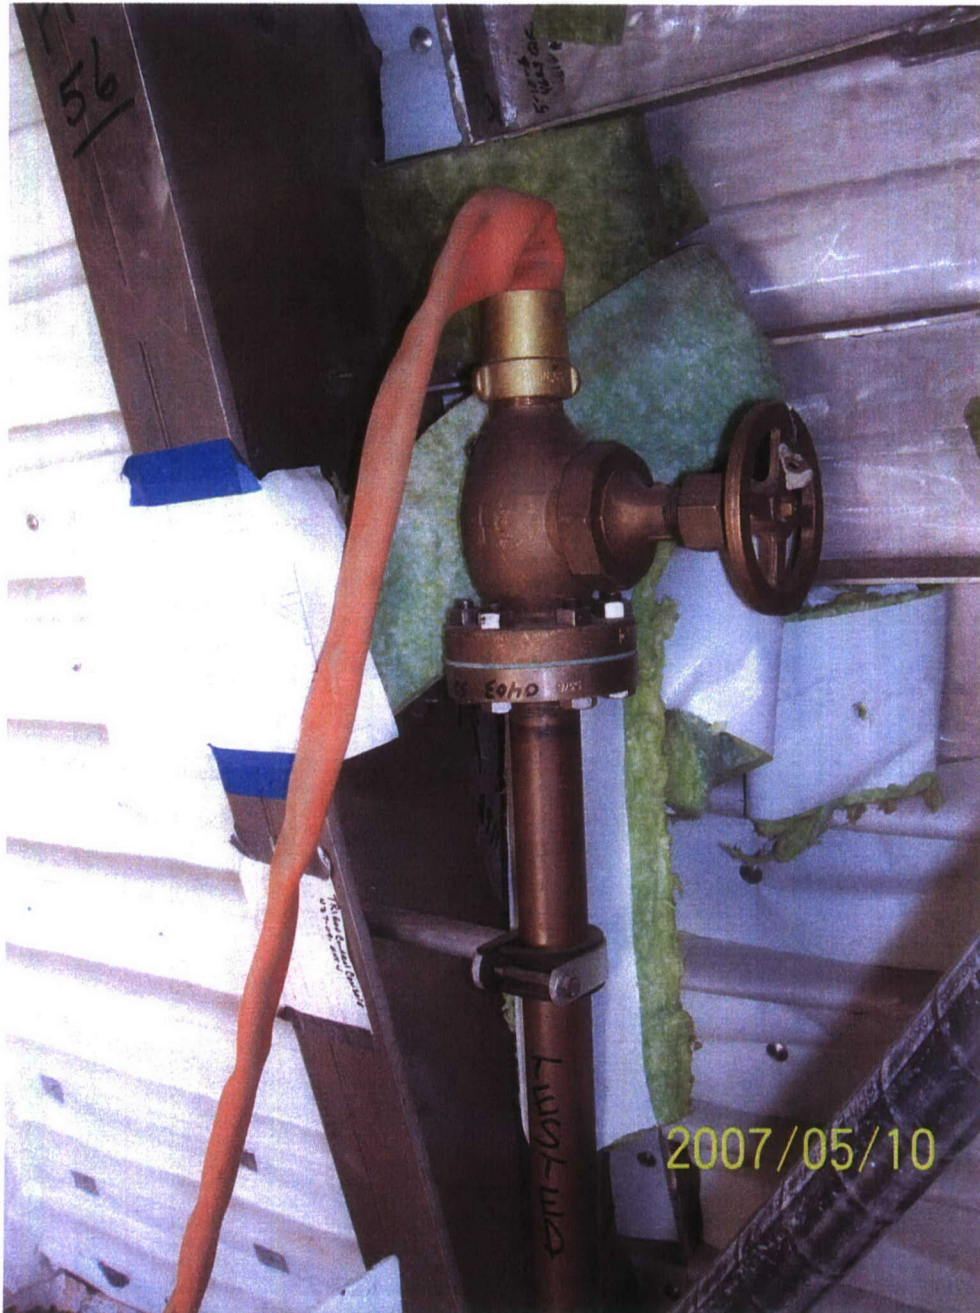
2. Starboard aft saltwater connection: This hose connection is pointing up (Figure 6); it is required to point down or horizontal to prevent kinking of hose. (per NVR: Part 5, Chapter 4, Section 3, Paragraph 1.7, "Fireplugs shall be positioned so that the valve hand wheel is approximately 1.8 m (6 ft) above the deck with the hose end downward").

FIGURE 6. Starboard AFT Saltwater Discharges Pointing Up Will Likely Result in Kinked Hose When Charged and Pulled.

The proposed correction for this situation is to correct the position of the saltwater connection to point down. In addition, installation of a hose tray in lieu of a camelback rack between ship frames approximately 3 feet above the deck, with direct access to the door of the flight deck, would permit one person to grab the hose nozzle and pull hose through the door feeding directly off of the tray. A structural fire apparatus hose fold can be utilized to assure proper playing out of hose off of the tray. The NAVAIR Fire Protection Team can provide guidance to the ships crew and to the training schools on this hose fold. Exact hose tray design and placement will be determined in collaboration with the LCS design team.

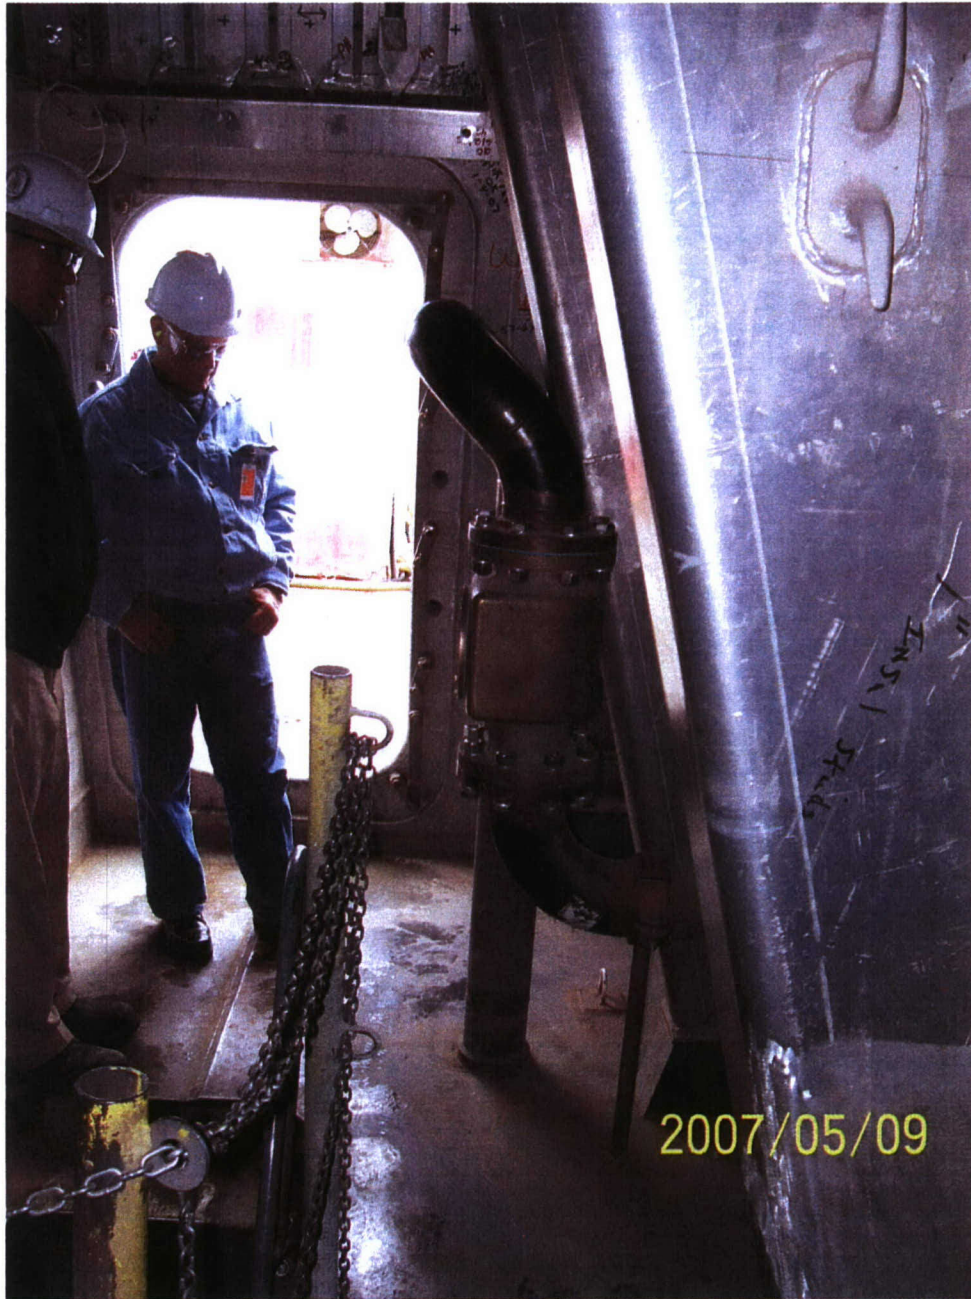
3. Port flight deck access vestibule: The fuel oil tank vent water vent/overflow plumbing is directly in the path of travel for firefighting teams from the hangar to the flight deck (Figures 7 and 8).

FIGURE 7. Port Flight Deck Access Vestibule Looking AFT. Note narrow walkway created by piping obstruction.

Traversing this path is difficult under normal conditions. With the added bulk of proximity suits with SCBA, while pulling hose, this path becomes a serious safety concern, due both to the difficulty of traversing this space without damaging fragile proximity suits as well as the hazard of falling into the adjacent ladder well while negotiating around bulkhead frames and plumbing installations

The proposed correction for this situation is to reposition vent piping close to the skin of the ship and out of way of vestibule traffic to open this path of travel to an acceptable width.

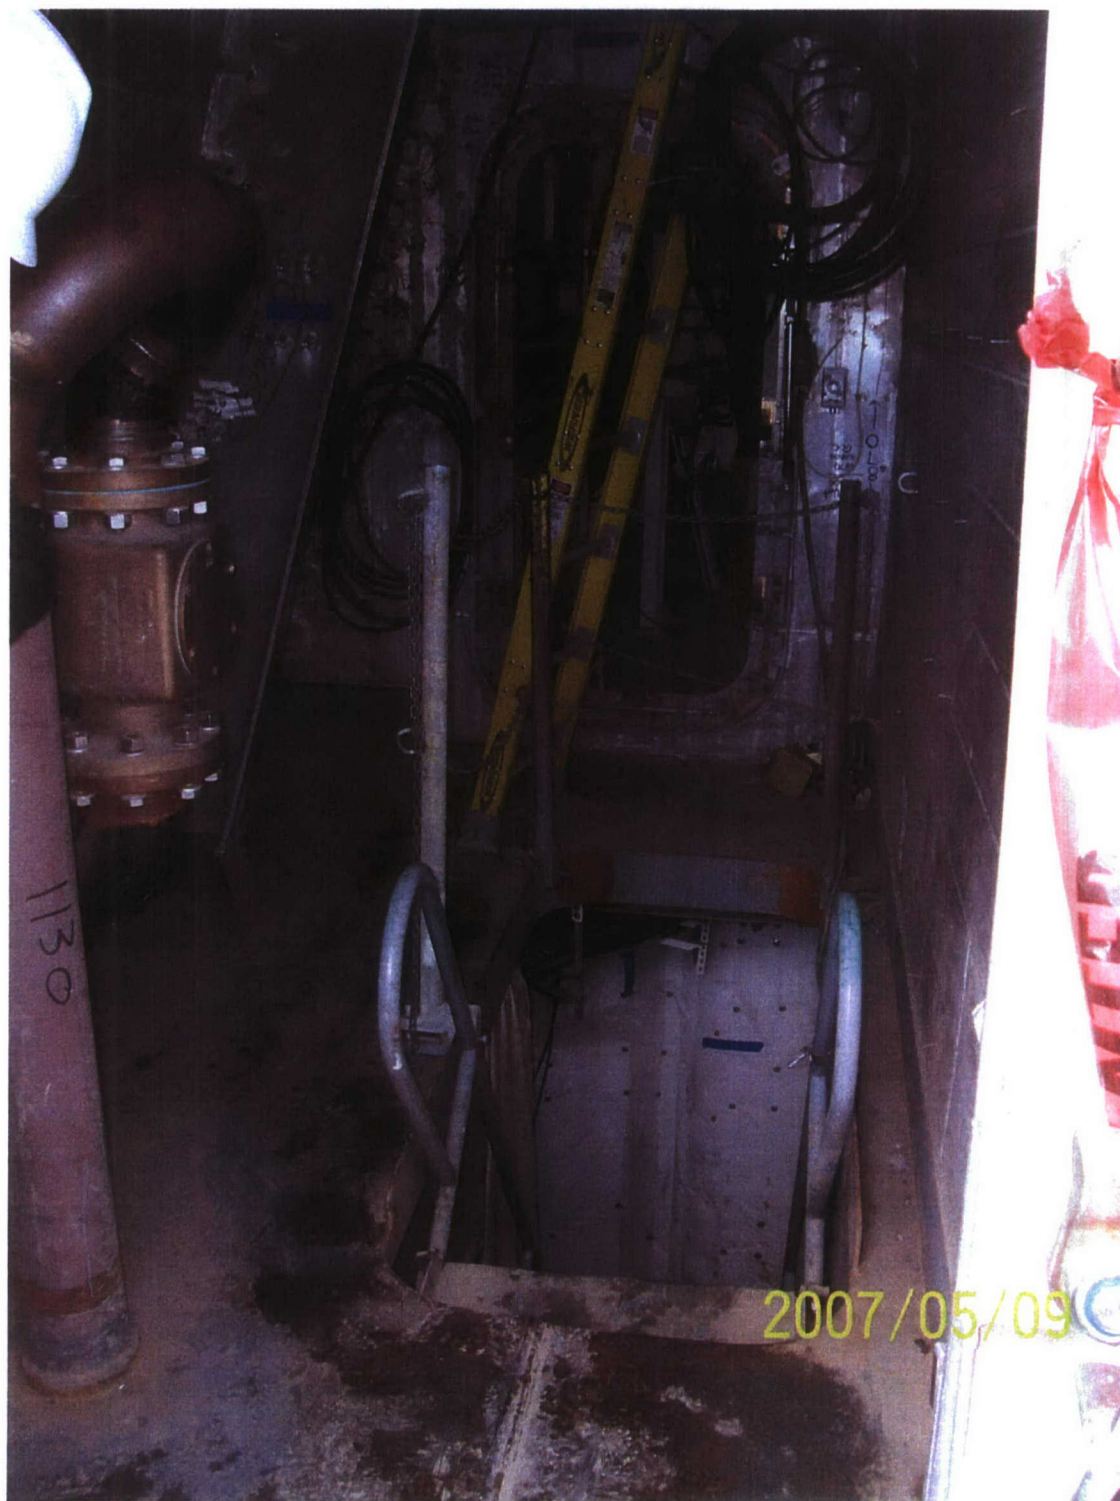
FIGURE 8. Port Flight Deck Access Vestibule Looking FWD. Note hazard of ladder way when attempting to pass piping obstruction.

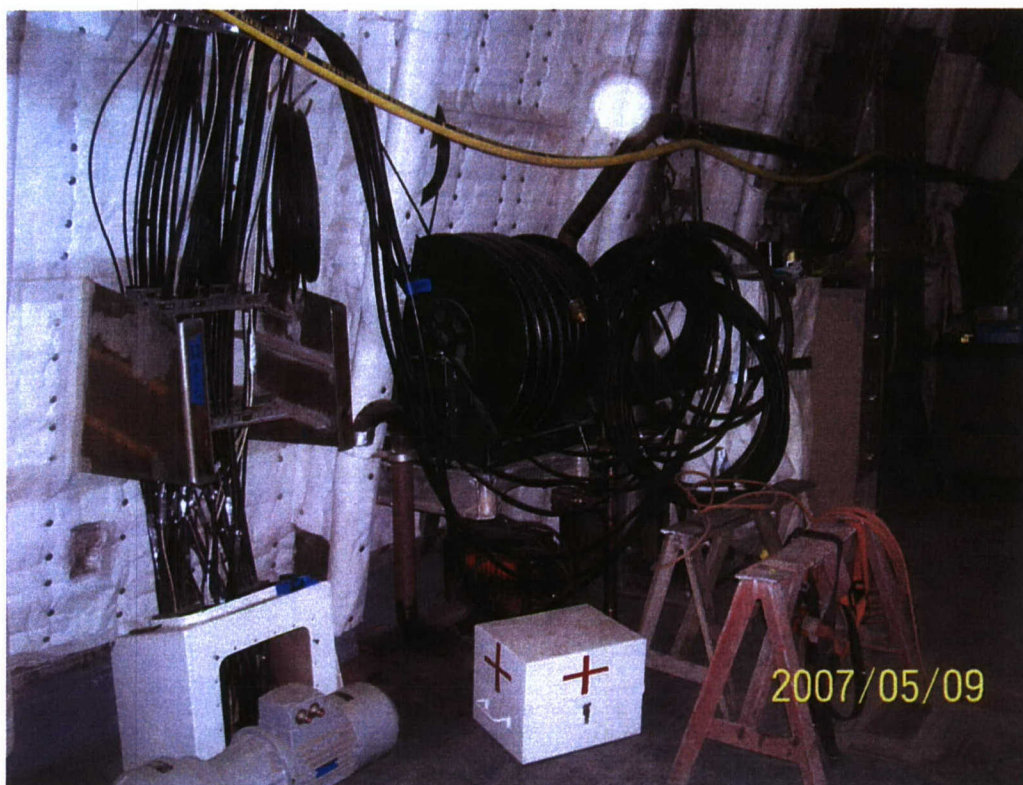
4. Port aft AFFF Hose Reel in Hangar: This hose reel is positioned low on the bulkhead with the barrel of the reel parallel to the port bulkhead, thus feeding hose inboard rather than aft toward the flight deck (Figure 9).

FIGURE 9. PORT AFT AFFF Hose Reel. Note payout is NOT in direction of flight deck.

In this configuration it will be difficult for the hose team to pull heavy charged fire hose over at a right angle, requiring a minimum of two personnel and a slower response time to deploy the hose. Flaking out hose on the hangar deck may help this situation, but would require hose to be played out in a primary personnel travel route from the interior of the ship to the flight deck. This travel route is already narrowed due to the placement of Mission Module Containers. The looping of the hose would also require one person to remain in the hangar as hose is being pulled to feed the hose through tight spots caused by the mission containers, doorways and ladder from the first deck.

The proposed correction for this situation is to install the hose reel higher on the bulkhead and turned 90° so that hose feeds aft off of the reel similar to the installation of the aft starboard reel. Installation of hose roller guides on the framing between the hose reel and the exterior flight deck door will also eliminate the difficulties of pulling hose through the two doors and around the access trunk ladder. This will permit the hose nozzle to be positioned at the door during flight operations. A single person will be able to immediately grab the nozzle as they exit the door and pull hose being fed off of the reel without the need to wait for a second person. Exact reel placement and roller design and placement will be determined in collaboration with the LCS design team.

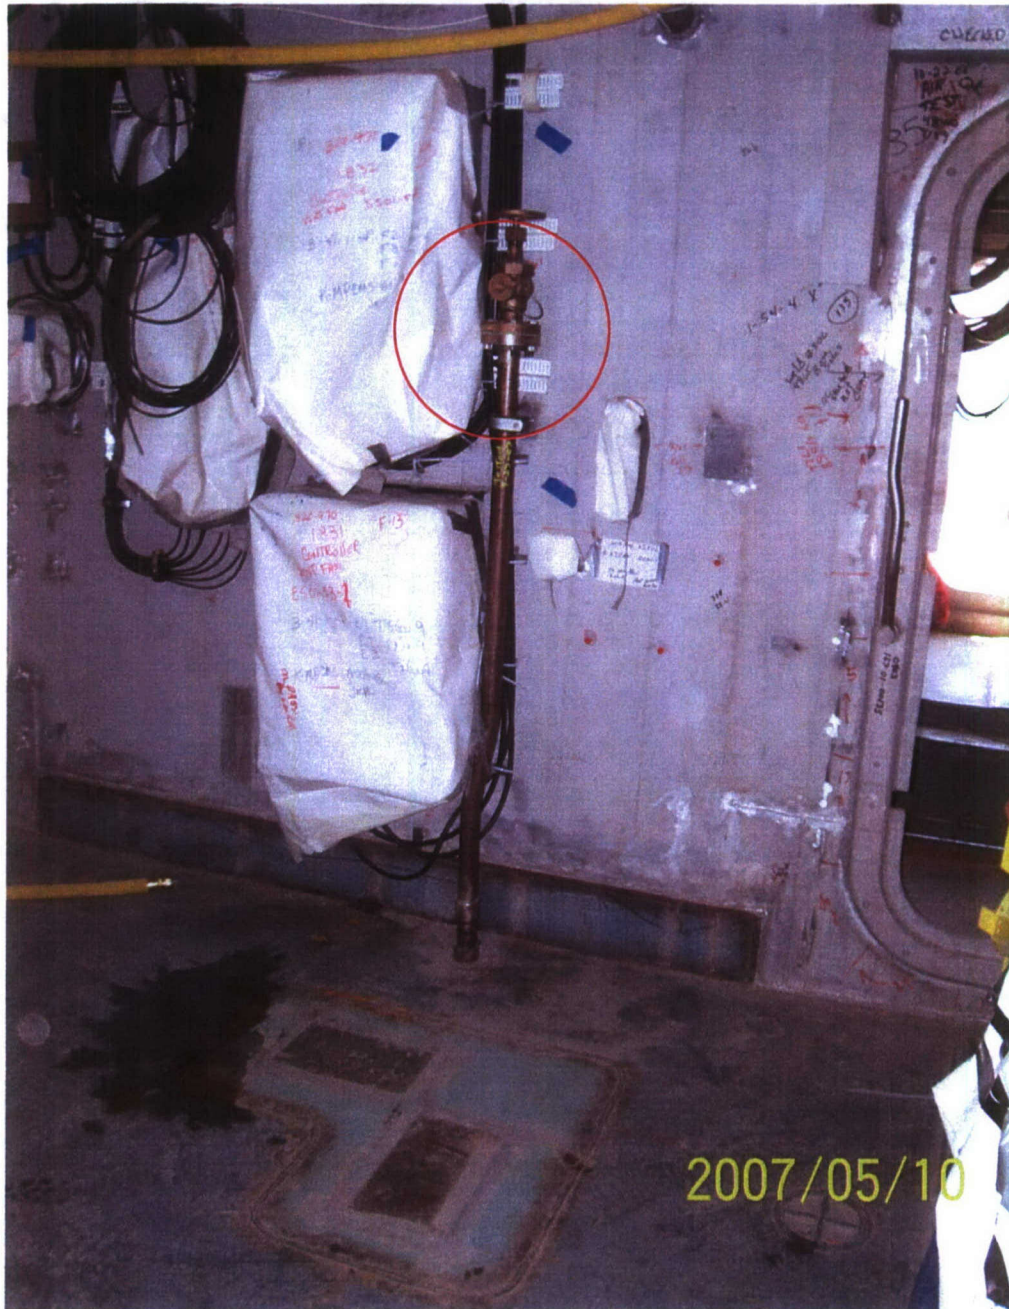
primary path of travel from the ship's interior to the flight deck. This travel route is already narrowed due to the placement of Mission Module Containers. Another problem with this location is that the hose connection port on the valve points forward, potentially causing a charged hose to kink against the Mission Module Container (Figure 10).

FIGURE 10. PORT AFT Saltwater Discharge with Mission Module Corner Pad on Deck. Tight clearance between discharge and module will likely cause hose to kink when charged.

In order to correct the problem of kinked hose against the Container, the valve could be turned so that the hose connection port points toward the nearby starboard hatch.

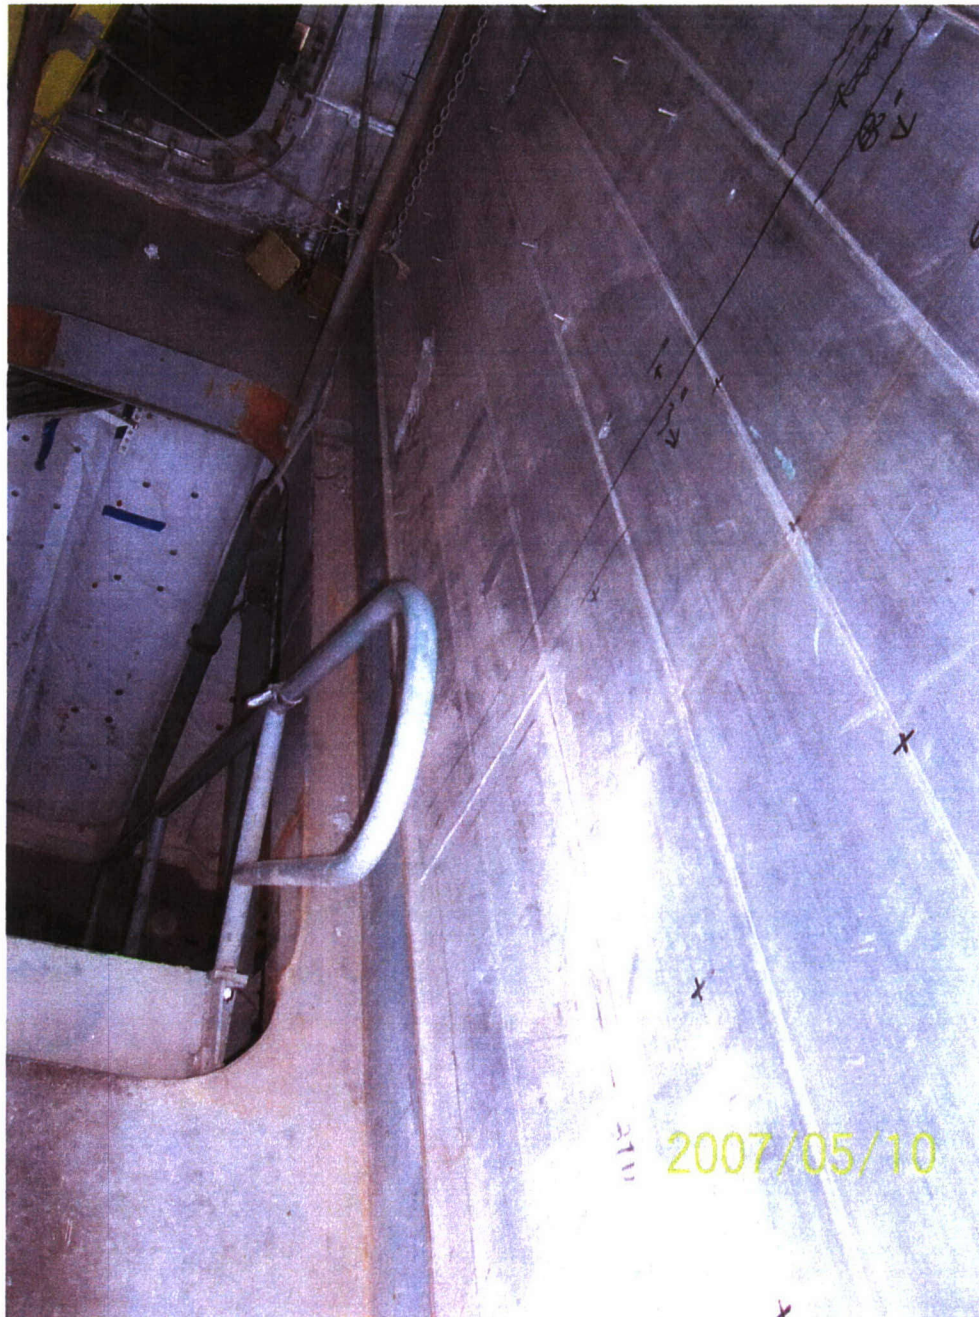
FIGURE 11. Area Between Ladder Well and Bulkhead is the Suggested Location for a Hose Tray in PORT Flight Deck Access Vestibule.

The proposed correction for this situation is to install in the vestibule in the gap between the bulkhead and starboard edge of the ladder well, a hose tray along the inboard bulkhead in the access trunk (Figure 11).

The hose would be connected as needed to the saltwater connection during flight operations and disconnected after flight operations have been suspended so that the door can be closed. This arrangement would permit one person to grab the hose nozzle and pull hose through the door feeding directly off of the tray. A structural fire apparatus hose fold can be utilized to assure proper playing out of hose off of the tray. The NAVAIR Fire Protection Team can provide guidance to the ships crew and to the training schools on this hose fold. Exact hose tray design and placement will be determined in collaboration with the LCS design team.

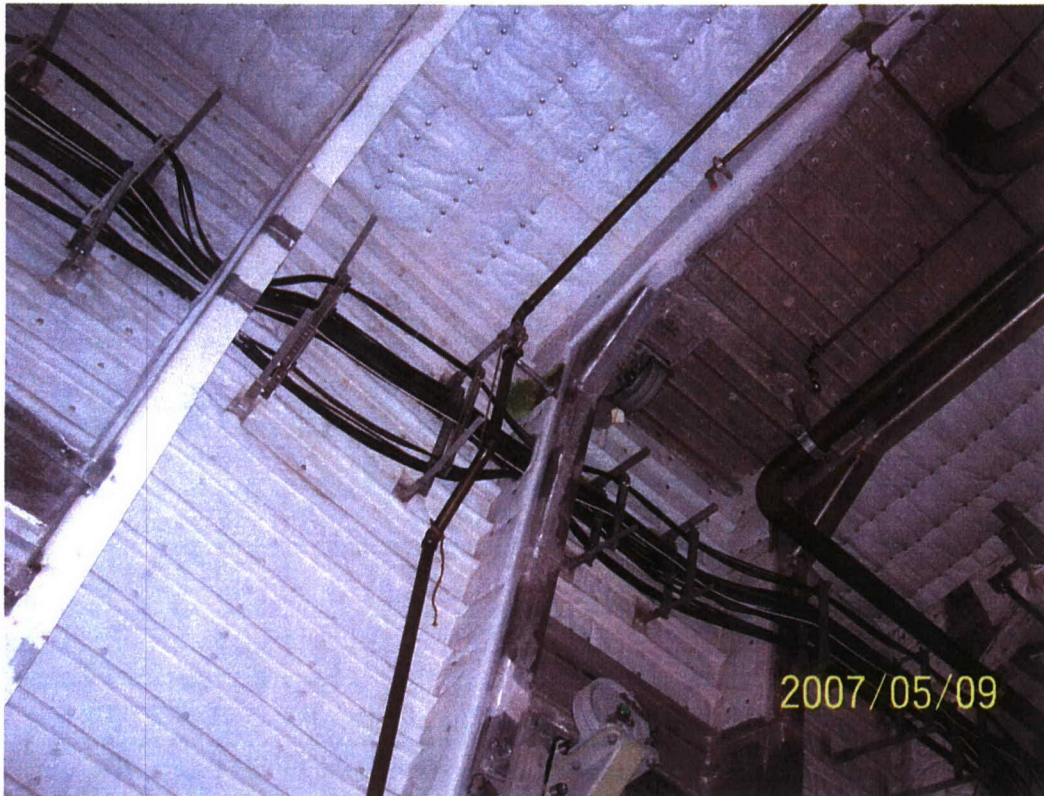
8. AFFF Station and Saltwater Connection Supply Piping: All Hangar Deck and Flight Deck AFFF and saltwater connection piping that were viewed during the evaluation aboard Freedom were found to be predominantly small diameter piping (1.5") with long runs and many elbows, all generating significant friction loss (Figures 12 and 13).

There is concern that this plumbing will not provide the required minimum nozzle pressure of 70 psi while flowing that is required per NVR Part 5, Chapter 4, Section 3, Paragraph 3.3.2. Inadequate flow will obviously provide insufficient firefighting and weapons cooling capability.

FIGURE 12. 1-1/2" Piping Running Up, Overhead, and Back Down to Feed STBD FWD Hose Reel from Opposite Side of AMZ.

The proposed correction to this situation is to conduct flow tests of each component (AFFF hose reels, saltwater hose lines, flight deck flushdeck system and hangar overhead sprinkler system) to assure proper flow and make adjustments to the piping supply system as needed to meet minimum flow requirements.

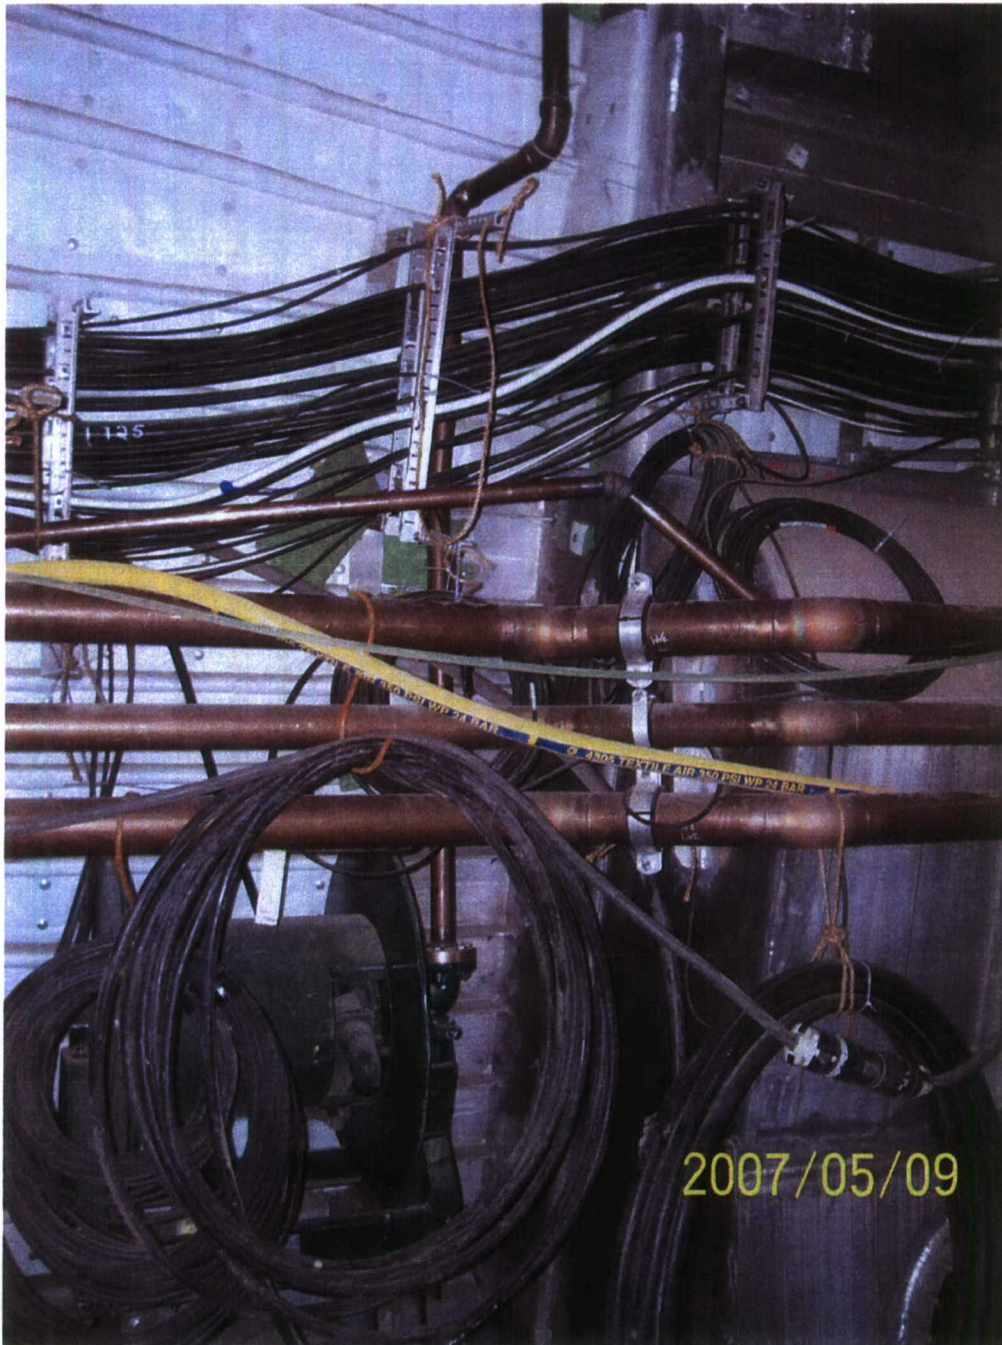
FIGURE 13. Lower Portion of 1-1/2" Piping Feeding STBD FWD Reel. Note number of bends in runs that will lead to a reduction in pressure at reel.

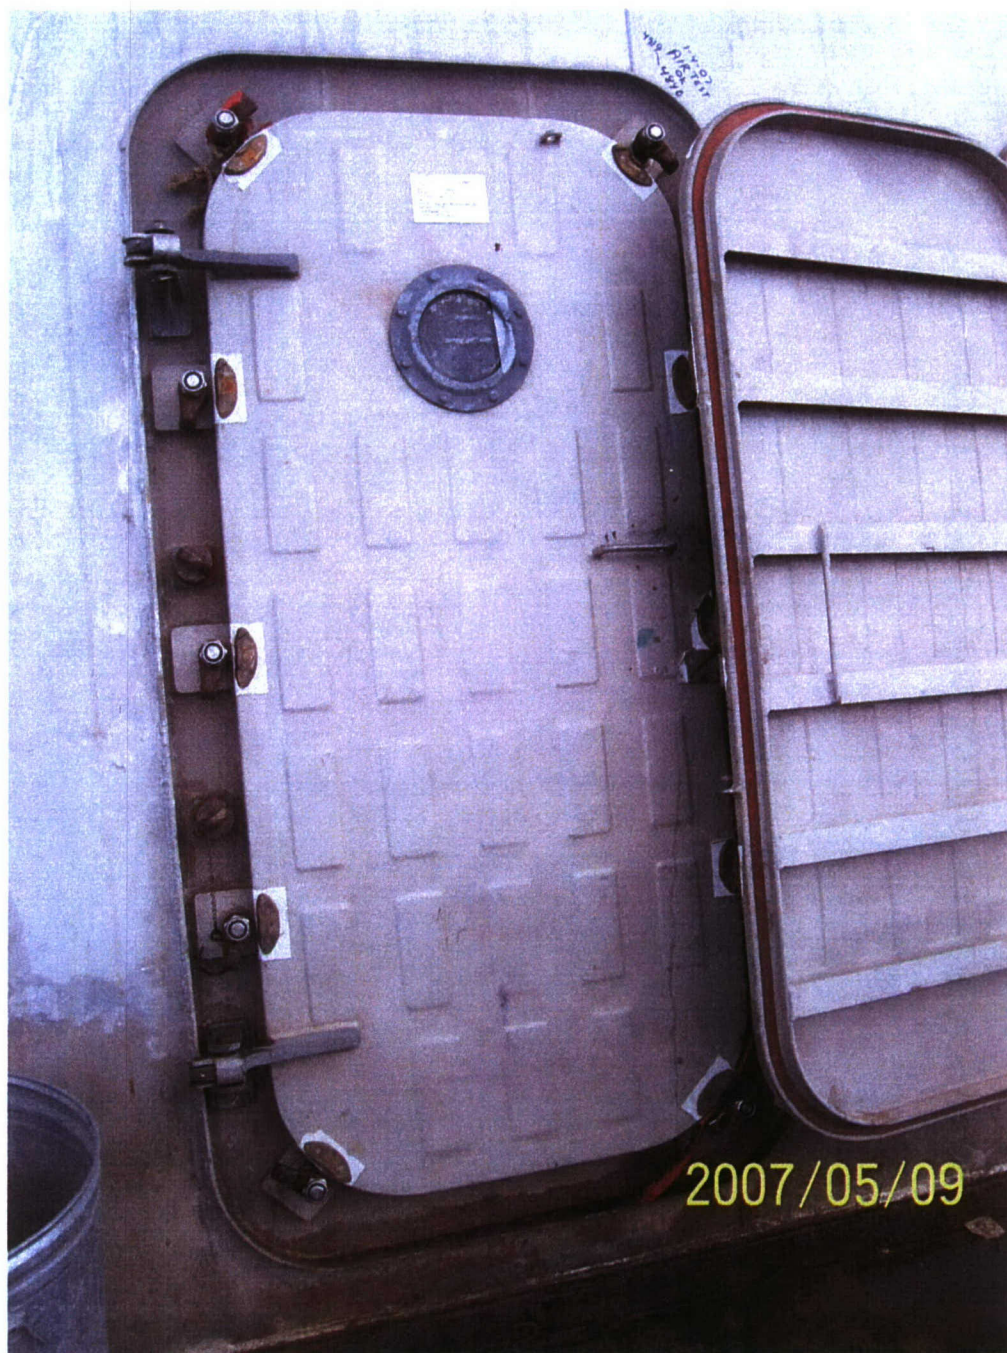
9. Flight Deck Helo Fueling Station Door/Hangar to Flight Deck Access Door Interface: When the Fueling Station door is in its fully open position, it overlaps onto the personnel access door, preventing it from being opened as can be seen in Figure 14.

FIGURE 14. PORT Flight Deck Access Door is Blocked by Open Fuel Station Door.

This is a primary access route to the flight deck for hose teams. Since fueling operations have potential for fuel spills and related fires, this needs to be corrected.

The proposed correction for this situation is the installation of the hold back device that will secure the fueling station door in an open position that does not block the personnel door, perhaps limited to a 90° swing.

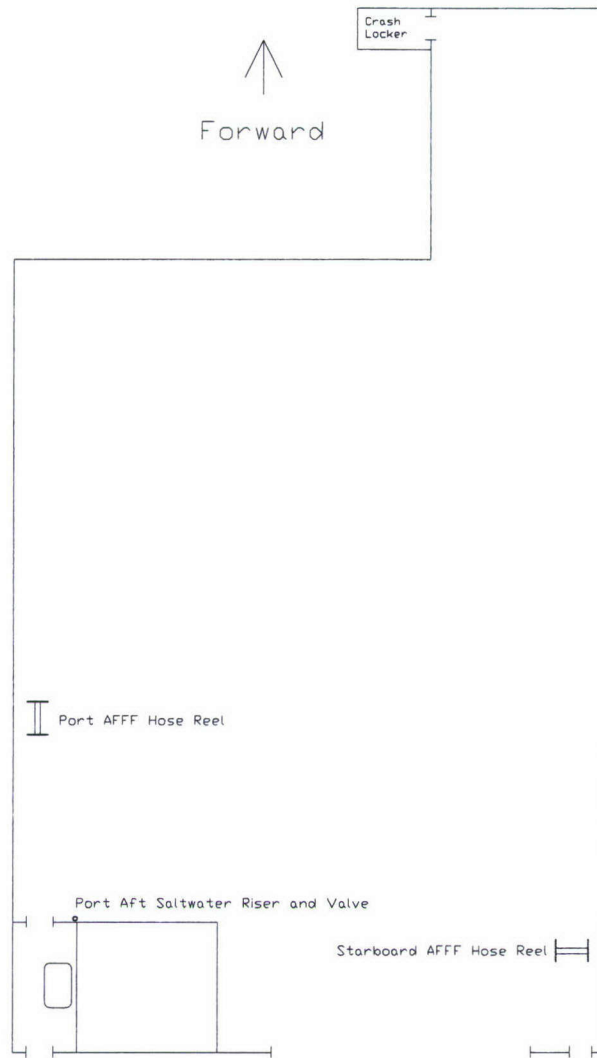
The NAVAIR Fire Protection team found several conditions in the ship design that inhibited efficient and effective flightdeck firefighting capabilities even with a complete NATOPS 00-80R-14 Chapter Nine flight deck staffing. The team has identified some changes or additions to ship installations and space assignments that could drastically improve the emergency response capabilities to the flight deck. The Team believes that these changes are reasonable, relatively minor and should not interfere with other ship operations. This will need to be confirmed with the rest of the LCS team. For reference at the end of this report, Figure 15 shows the layout of the LCS mission bay and hangar bay (mission module box locations are not shown).

FIGURE 15. General Arrangement of Mission Bay and Hangar Bay.
